Docket No. 217 – Development and Management Plan Inspection

Northeast Utilities Service Company Certificate of Environmental Compatibility and Public Need for the construction of a 345-kV electric transmission line and reconstruction of an existing 115-kV electric transmission line between Connecticut Light and Power Company's Plumtree Substation in Bethel, through the towns of Redding, Weston, and Wilton, and to the Norwalk Substation in Norwalk, Connecticut.

Date: July 22, 2005

Location: Transition Stations (Hoyts Hill, Archer's Lane)

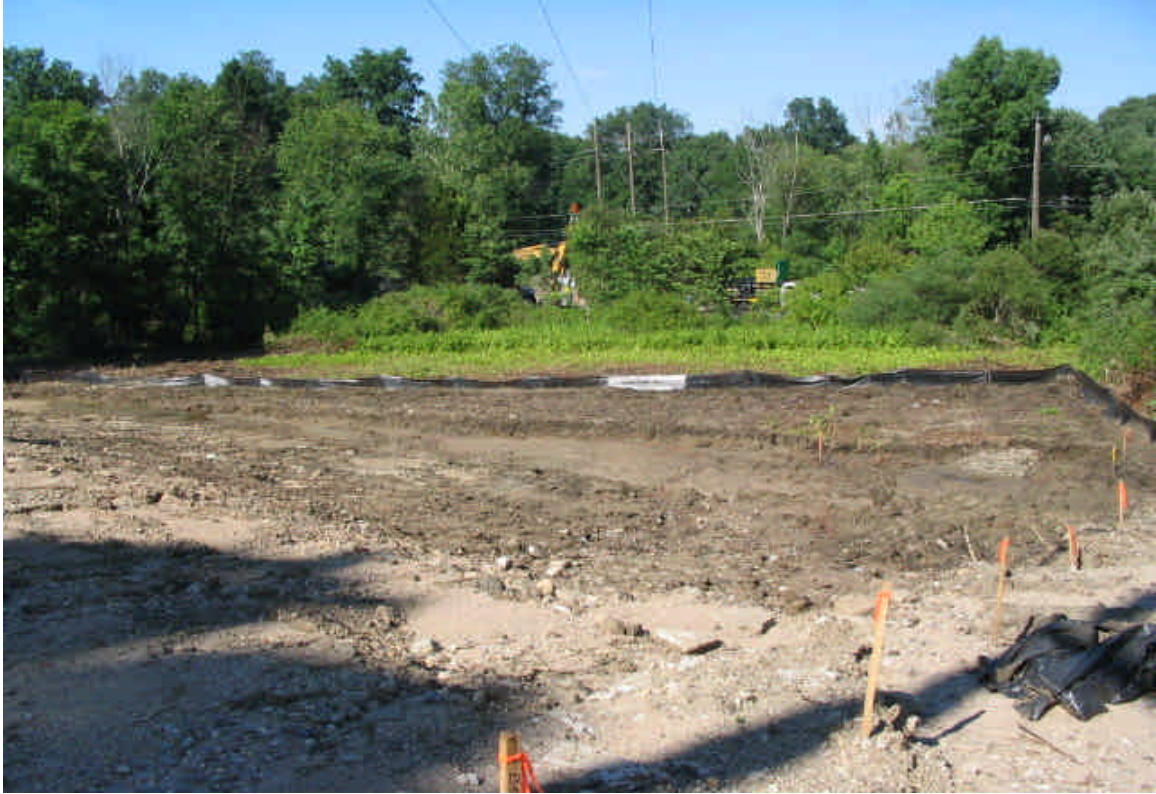
Hoyts Hill Transition Station: View of the cleared area within the ROW for the construction of the station. (7/22/05)

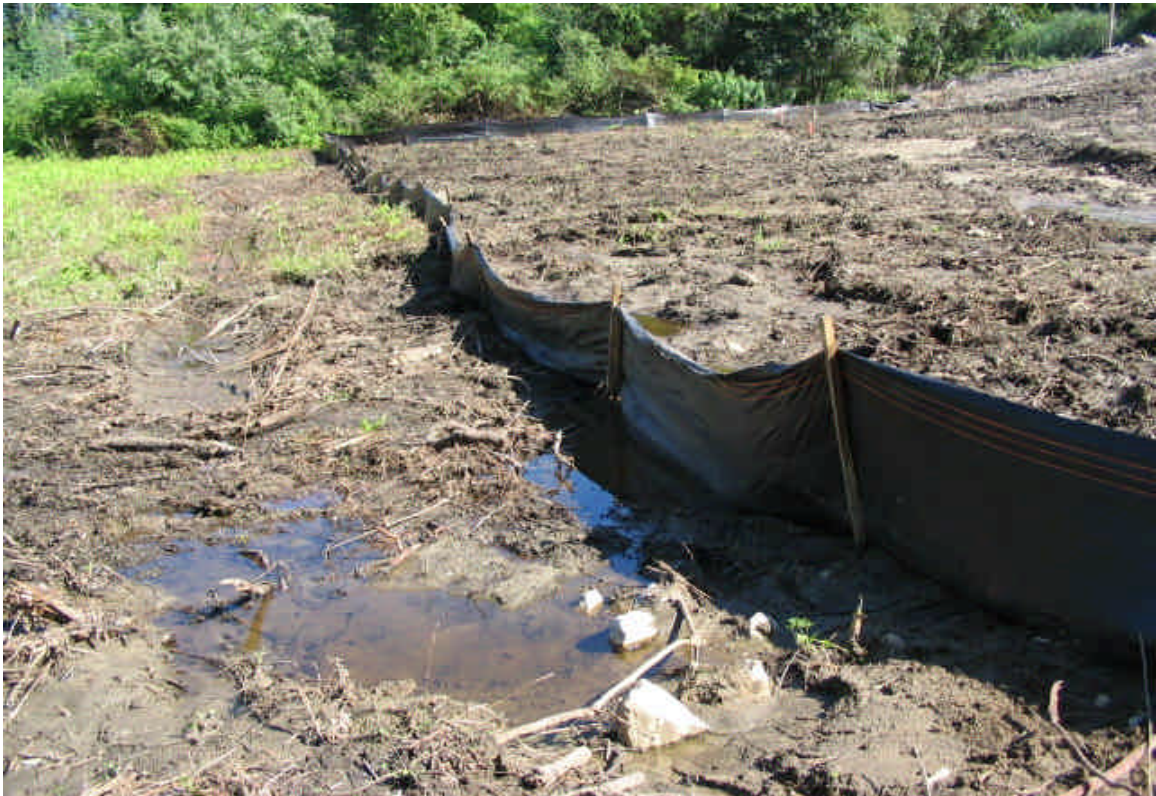
Areas of Inspection	Observation	Recommended Action
Erosion and Sediment Controls (includes inspection within 24 hours of a storm event)	<p>-Hoyts Hill: Silt fence is in place at the bottom of the slope at the edge of the portion of the wetland to remain undisturbed. It has come un-toed and worn in a number of locations. 7/22/05.</p> <p>-A large area of the slope has been cleared in preparation for the station but this had led to some gullying down the slope and sedimentation against the silt fence. 7/22/05</p> <p>- Several piles of soil are placed here at the top of slope. 7/22/05</p> <p>- A small area of sand/soil was noted on the other side of the silt fence in one spot. 7/22/05</p>	<p>- Several areas along the fence require repair. The worn areas should be replaced, the bottom of the fence should be buried 4-6 inches into the soil, and sediment should be pulled back where it has piled up 7/22/05</p> <p>- The fence could also be reinforced with staked haybales as an additional control. This is recommended here. 7/22/05</p> <p>- The slope should be placed with several check dams of silt fence or haybales which would help slow sedimentation before it reaches the only barrier. 7/22/05</p> <p>- This soil should be pulled back into the yard. 7/22/05</p>

View at the water filtering through the silt fence within the wetland. Although the water is clear at this time, repairs to the fence are necessary. (7/22/05)

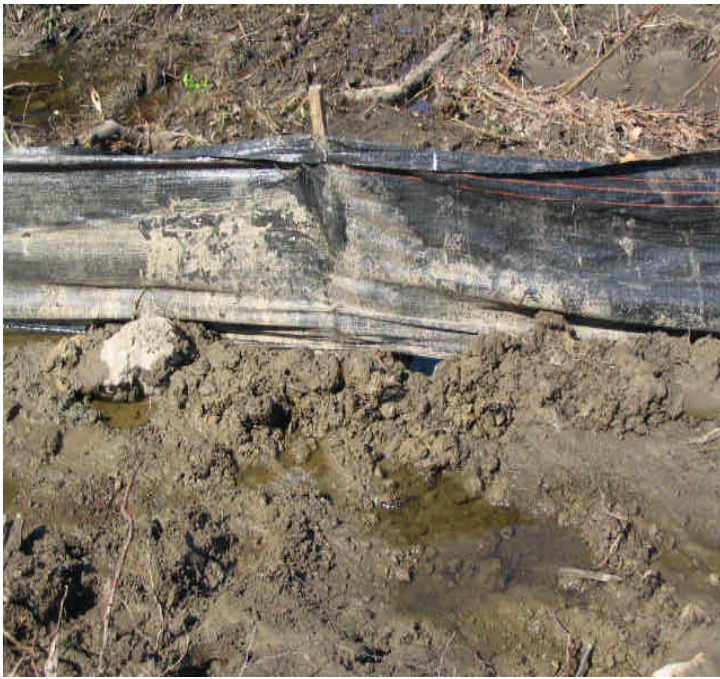
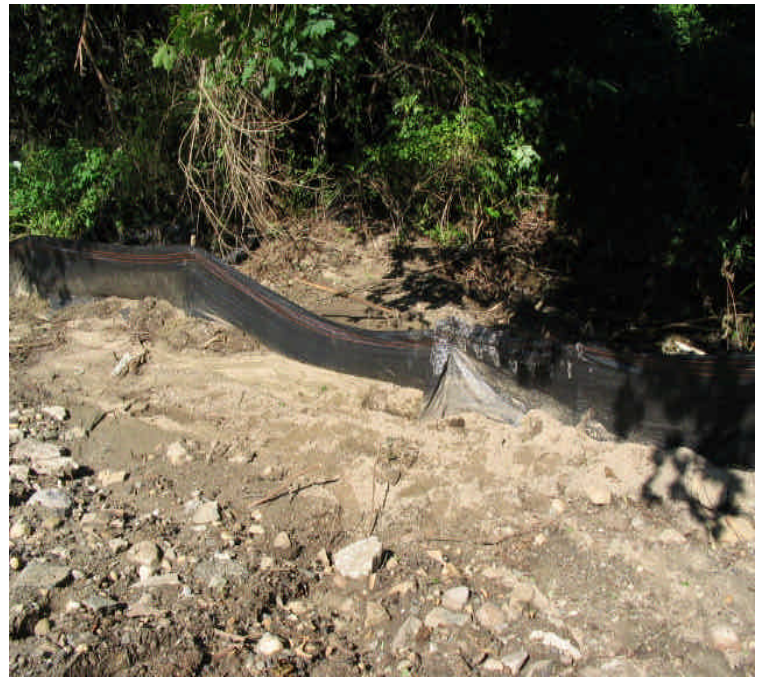
View of one of the areas where the fence needs to be toed in (on the left). View of the area where some sediment was placed beyond the fence and should be pulled back (on the right) (7/22/05)

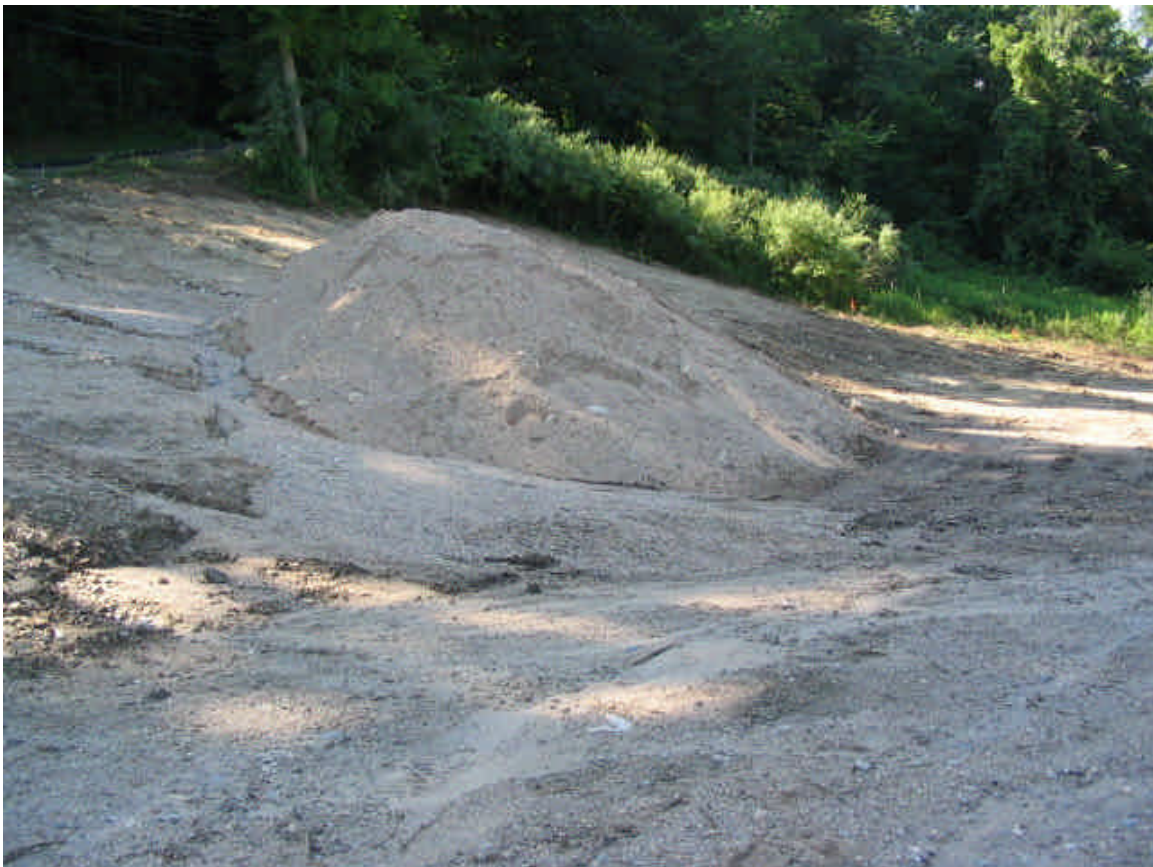
View of one of the sediment piles located within the cleared area. (7/22/05)

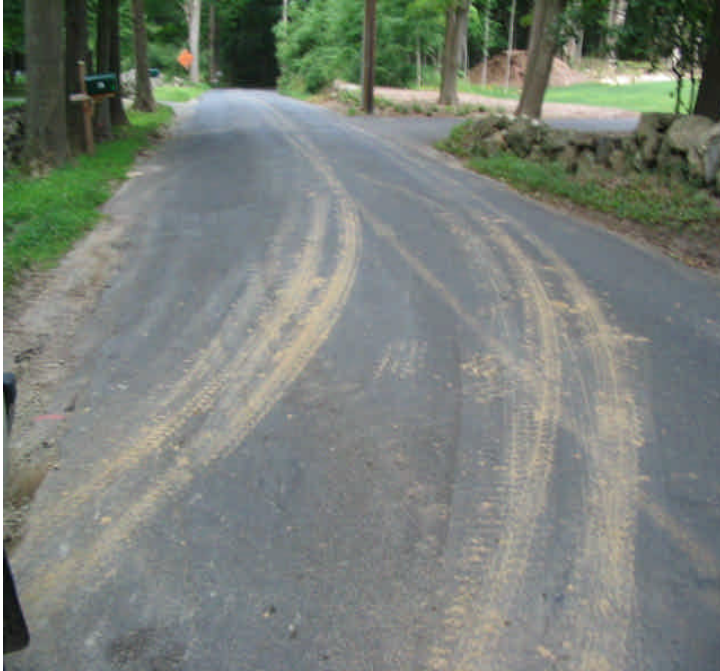
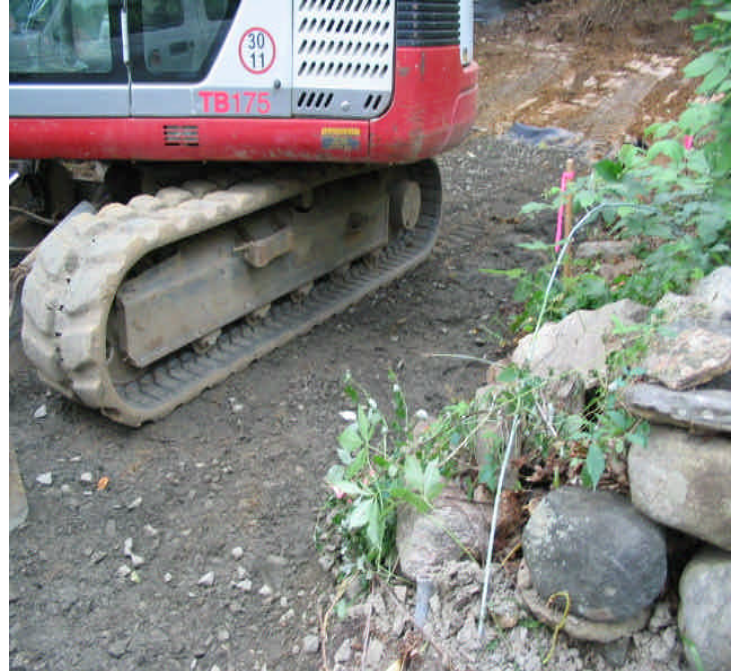
Archer's Lane Transition Station: Some minor sediment tracking is occurring to the roadway of Diamond Hill Road even though a construction entrance pad is in place. (7/22/05)

Areas of Inspection	Observation	Recommended Action
Access Roads and Adjacent Roadways	<p>- Hoyts Hill: No new access roads have been constructed. Access is gained off Hoyts Hill Road which was recently repaved and curbed by the DPW. Vegetation has been cleared along the edge of the roadway as a result of the roadwork, including up to the edge of a small stream. 7/22/05</p> <p>- Archer's Lane: A new access road is being cleared and grubbed from Diamond Hill Road several hundred feet to the transition station site up near the ROW. 7/22/05</p> <p>- A stone dust construction pad is well in place at the edge of the roadway. However, some minor sediment tracking has occurred out to the pavement. 7/22/05</p>	<p>-None at this time 7/22/05</p> <p>- It should be determined when the street gets to the point that it needs sweeping or larger stone could be installed on the construction pad. 7/22/05</p>

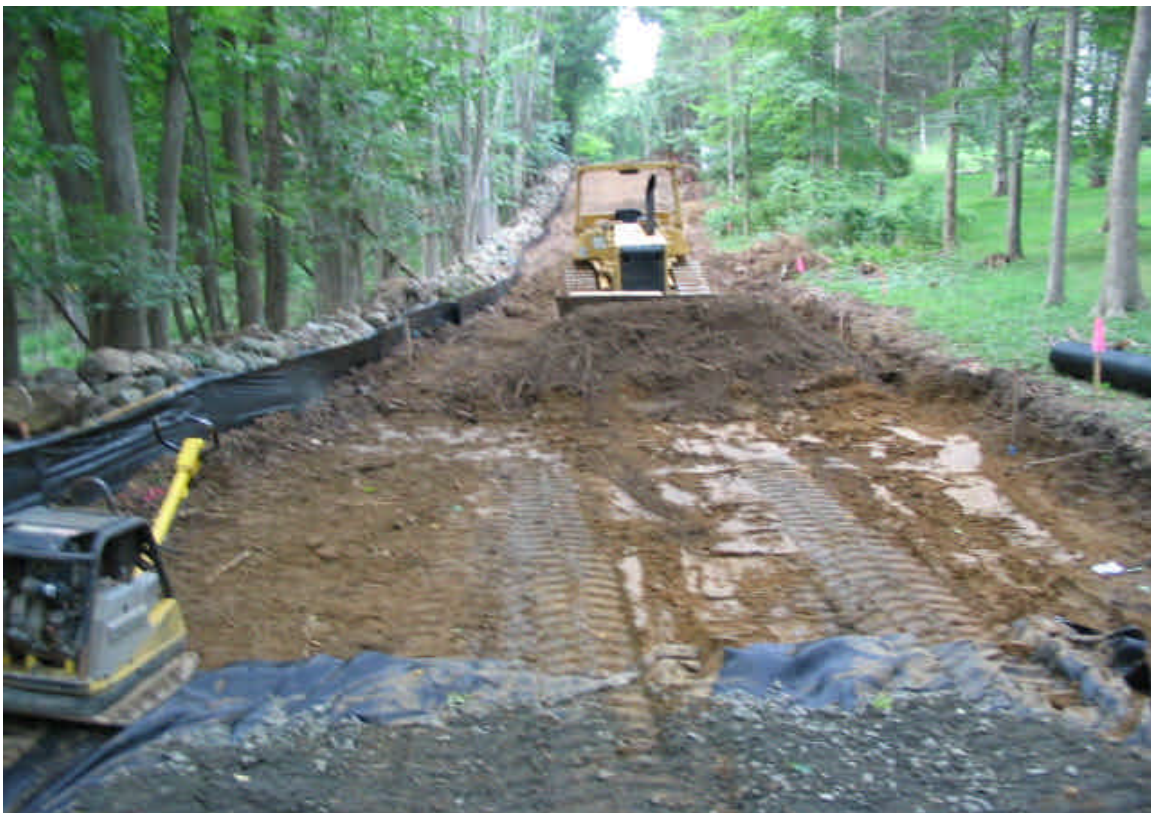
View from the construction pad looking out towards the clearing and grubbing for the access road. (7/22/05)

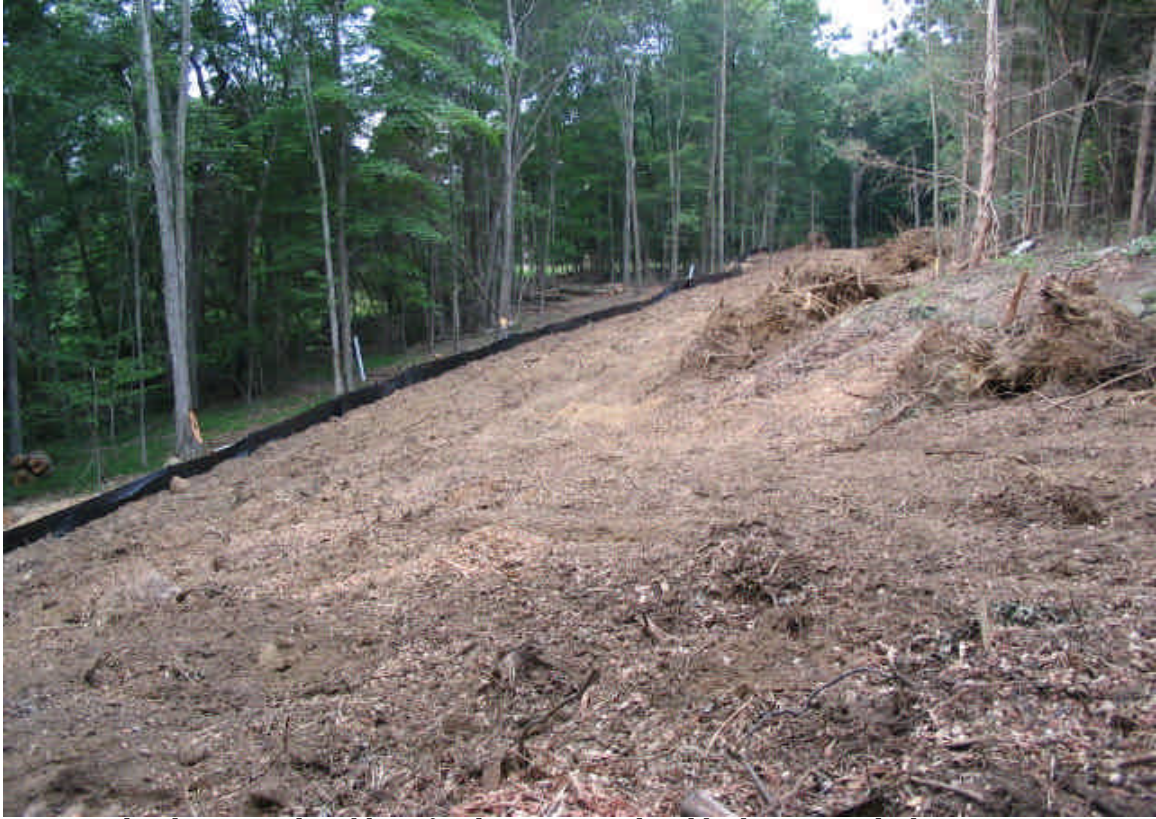
View at the clearing and grubbing for the access road and looking towards the transition station site. (7/22/05)
